2017 and 2018 (so far) OE Review

Gary Boles
Principal Technical Leader, NMAC
FLMUG
January 2019

Leaks Causing Shutdowns 2018 (reported as of 10/18)

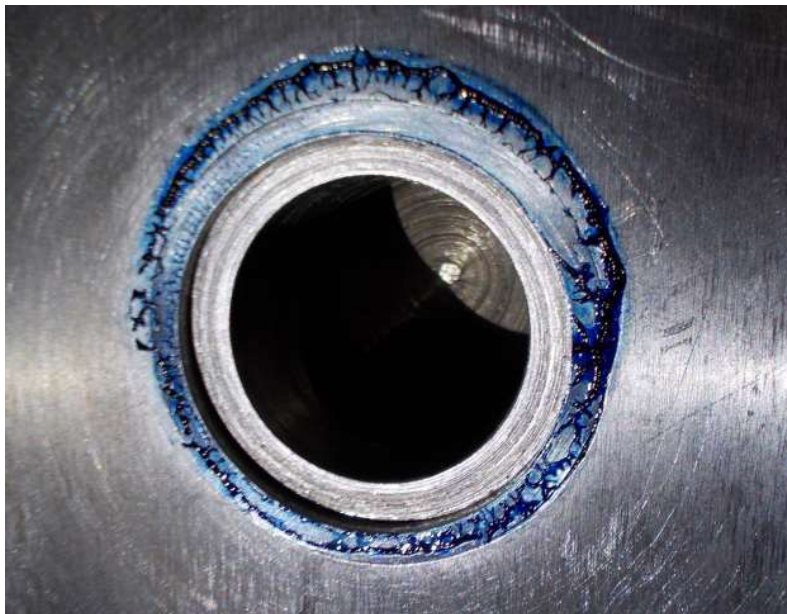
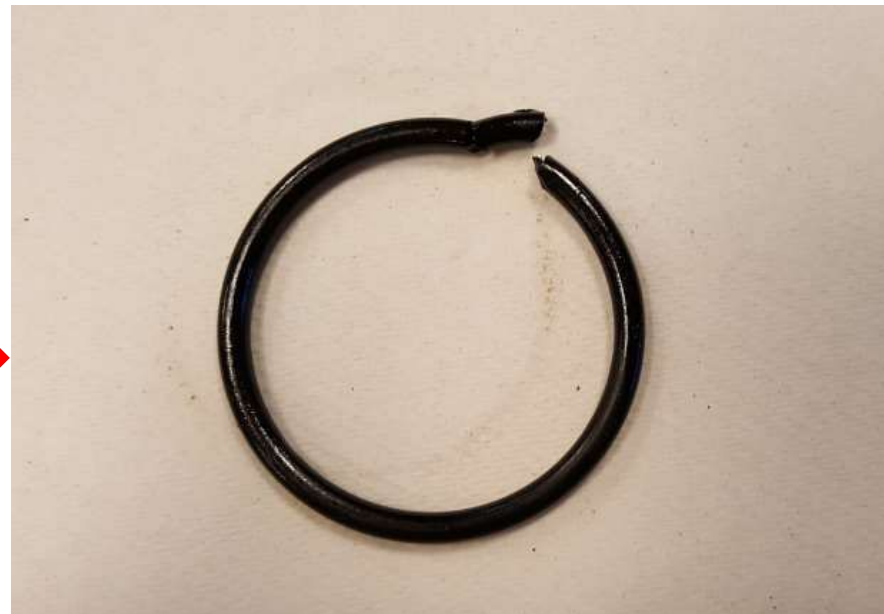
Repeat Failure of O-ring in MSIV Hydraulic Actuator Block Causes Shutdown

- The root cause of this event (RC-1) was the unresolved insufficient support of the O-ring provided by original design and manufacture
- This was a repeat failure which had an unknown root cause when it occurred the first time

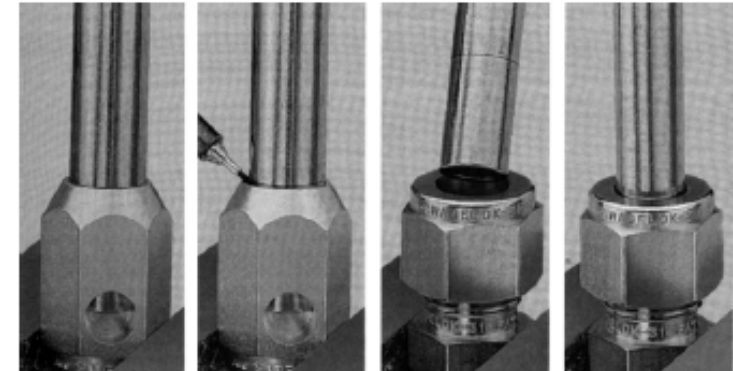
Figure 5-10
Swagelok DMT

The Swagelok depth marking tool (DMT) is designed to provide safe installation of tubing into Swagelok tube fittings. Following are suggestions on how the DMT (shown in Figure 5-10) will ensure proper bottoming of the tubing on the shoulder inside the Swagelok tube-fitting body.

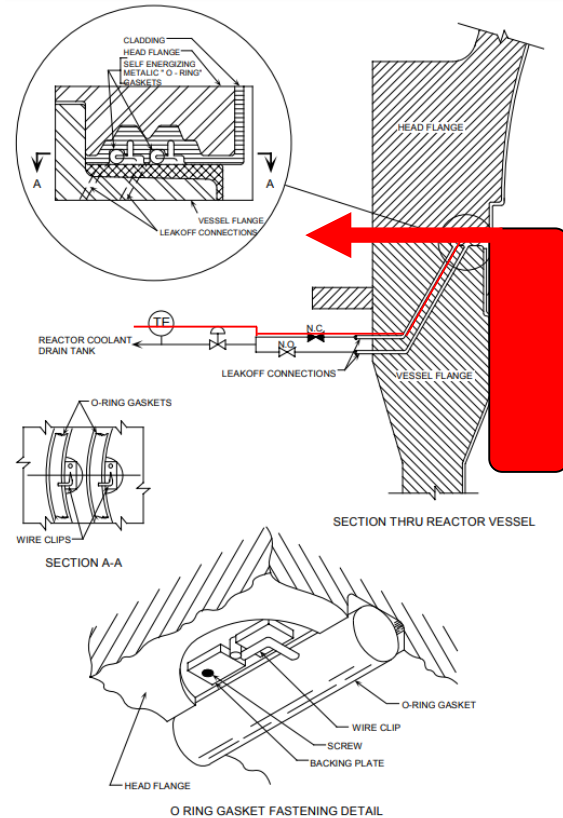
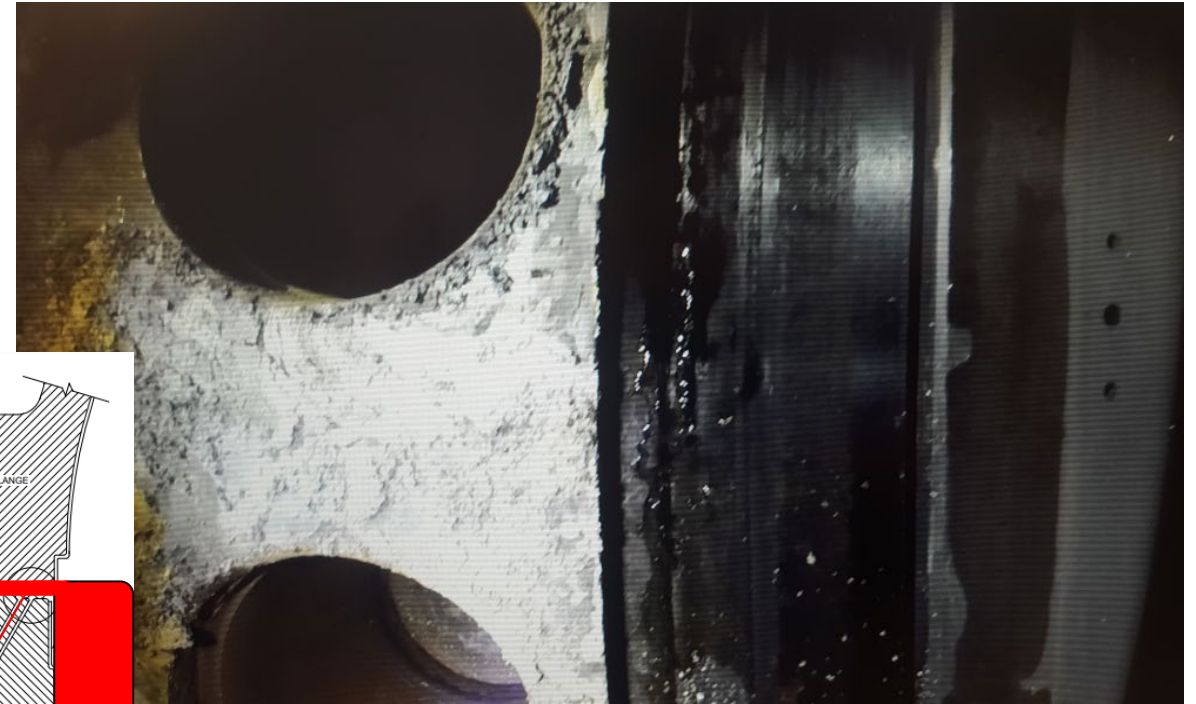
Reactor Vessel O-ring Leak Caused Shutdown (Repeat Event)

- Inner and outer Rx head O-Ring seals were compromised with a black oxide (FME) layer that caused a leak path around both O-rings caused by recent variations in the RHR flow while starting, stopping and swapping pumps during the period after the Reactor Head is landed but before it has been tensioned which has caused borated water (RCS) to be pushed up through the Upper Internals and then contact the flange surface and O-Rings.
- This causes the O-Rings sealing surfaces to become contaminated with debris and compromises the O-Ring seal.
- Previous cause evaluations have not captured all of the O-ring failure causes, resulting in actions not being put into place to completely prevent recurrence.
- Potential causes of the current inner O-ring leak are thought to be flange defects and/or the decontamination processes, as discussed in the FMA.

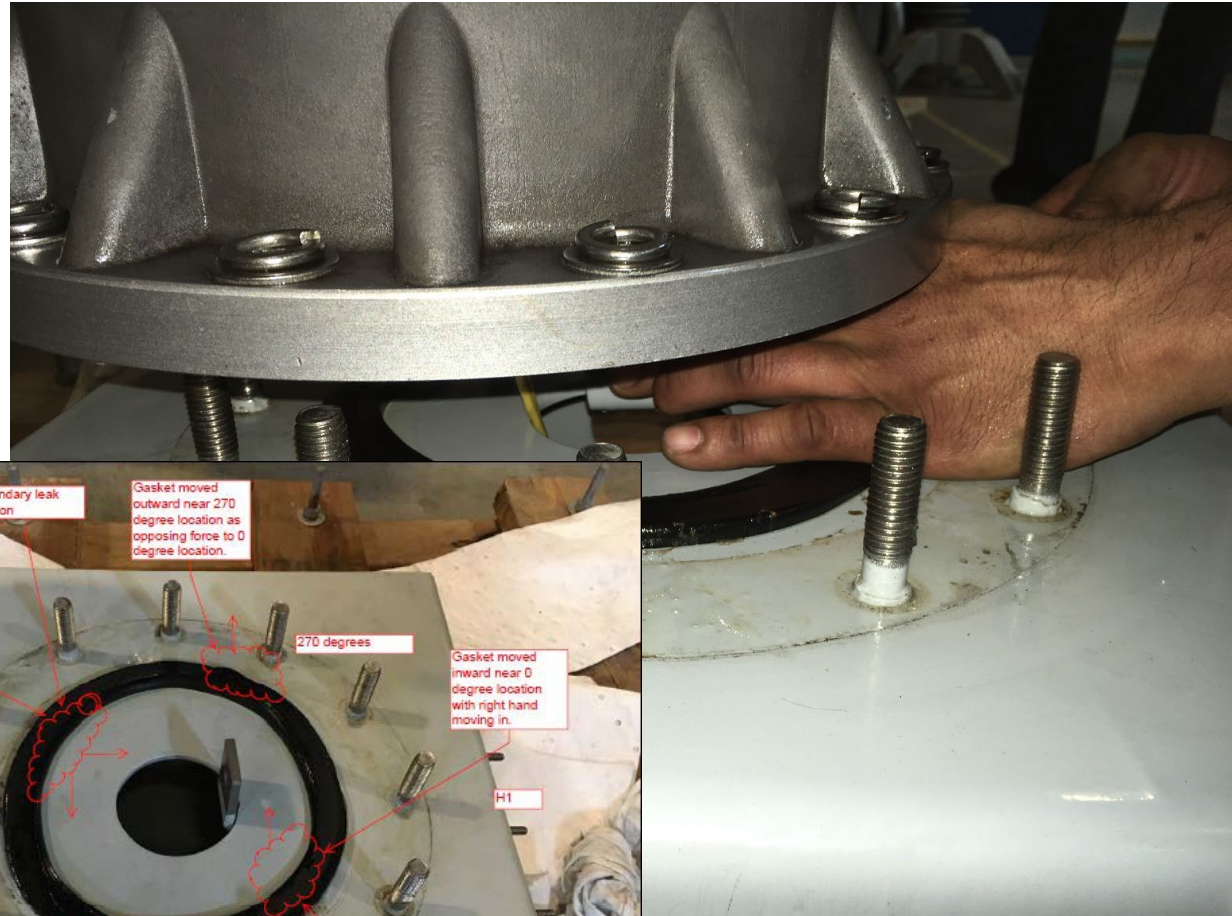
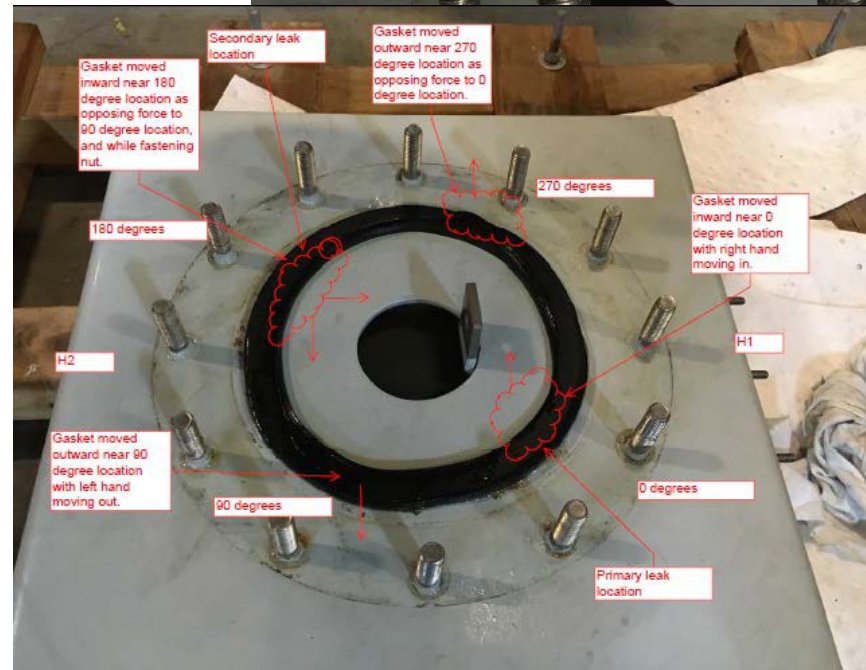
Gasket Leak on Revenue Measuring Current Transformer Flange Causes Shutdown

- Reaching in to connect a wire moved the gasket.
- The torque sequence was also questionable

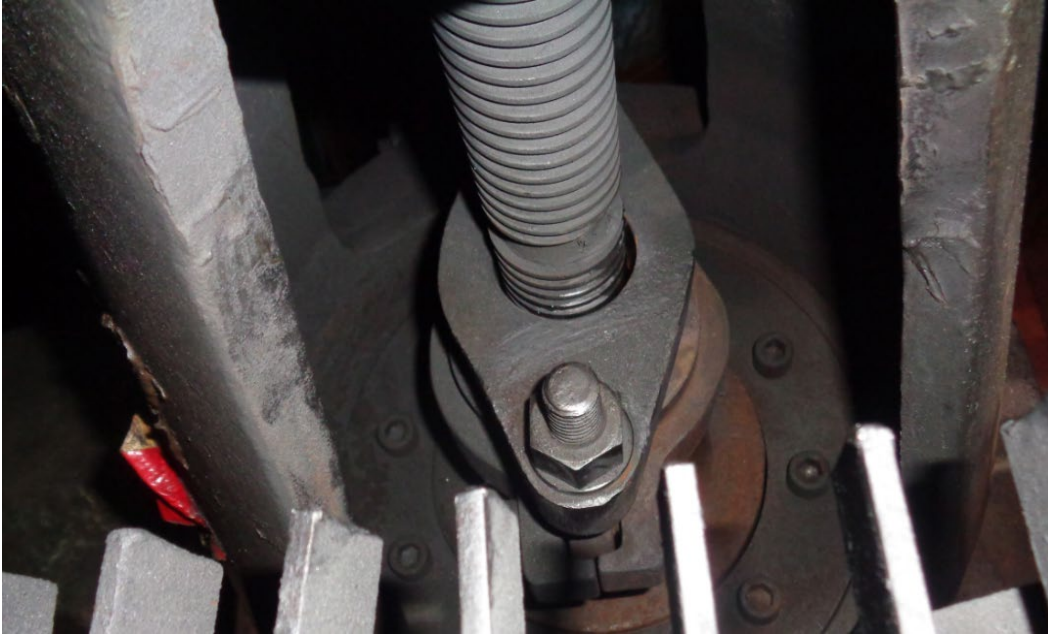
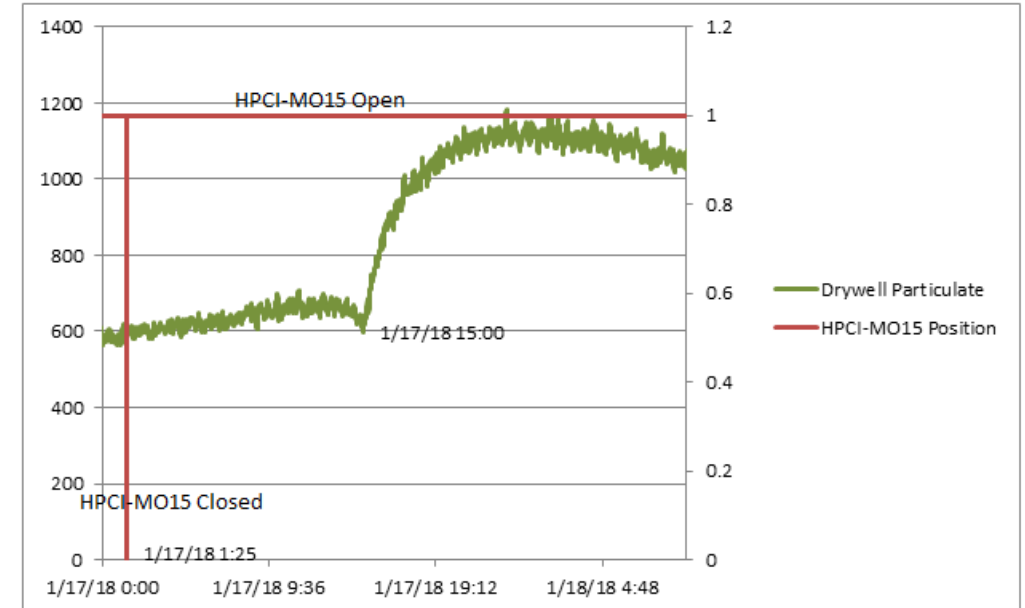
High Pressure Coolant Injection Valve Packing Leak Causes Unplanned LCO Entry and Shutdown

Root Cause: Packing consolidation and torquing methods were altered which impacted packing sealing performance to maximize the margin for the MOV along with following an over thrust event in 2006 and extensive valve work performed in 2008, declining valve performance was noted due to packing performance not monitored

Other Contributing Causes: stuffing box tolerances out of spec and packing was not resized, packing below minimum recommended loading after retightening was performed. Additional actions were not taken to address the low load.

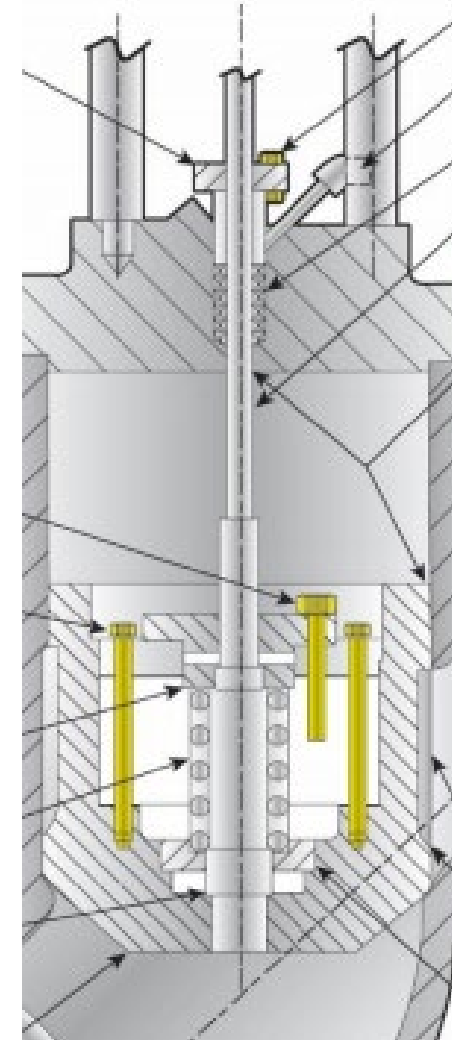
MSIV Packing Leak Causes Shutdown

- Packing load loss listed as cause
- Visual inspection of packing sealing areas found slight scuffing on the stem and minor pitting in packing chamber which could have contributed to the leakage

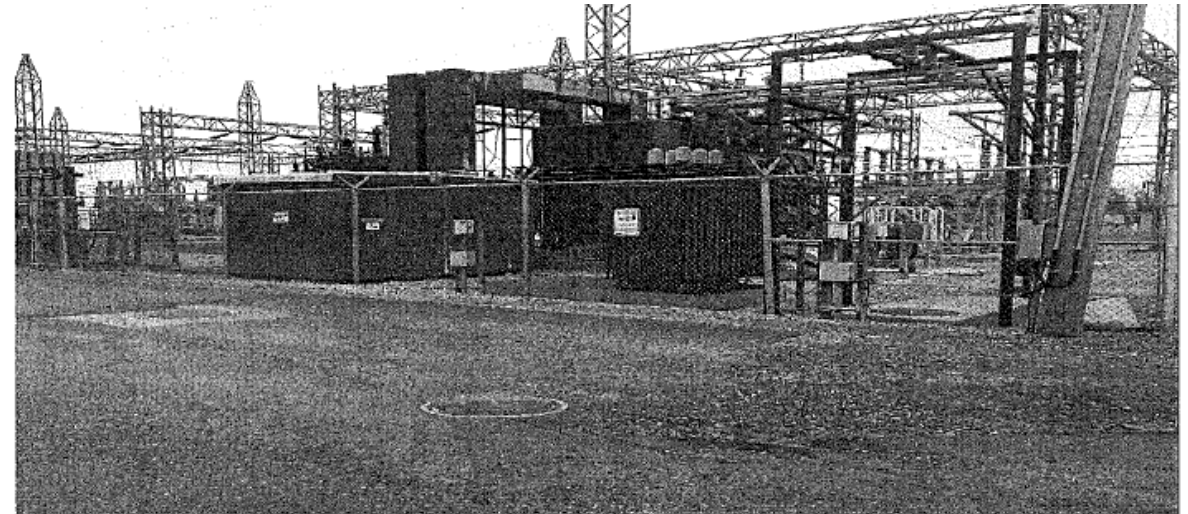
Degradation of Switchgear Enclosure Causes Shutdown

- Sometimes we have to keep water OUT
- Plant organizations tolerated low standards for material condition of outdoor metalclad switchgear

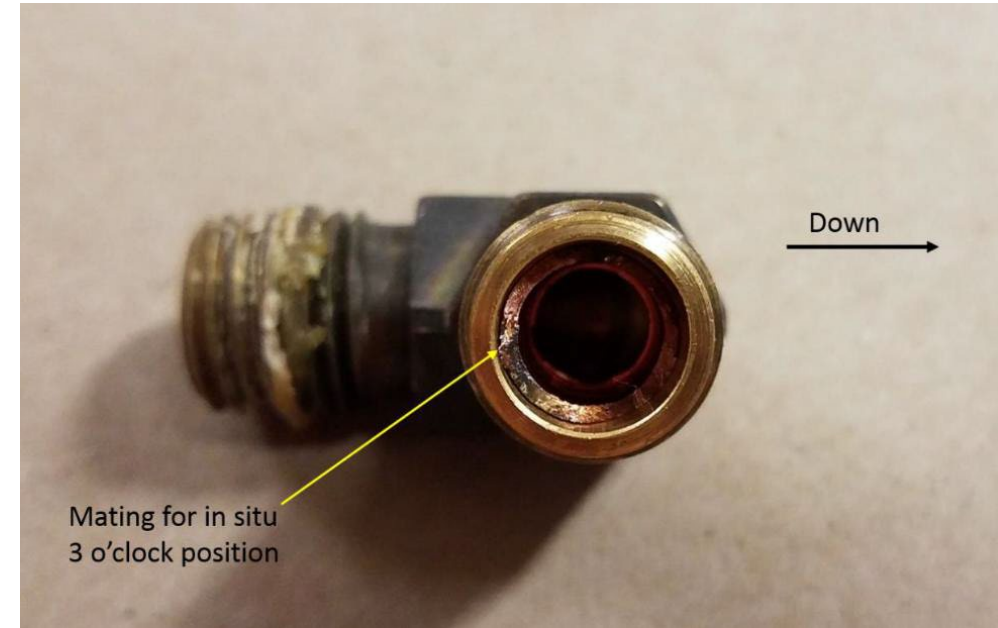
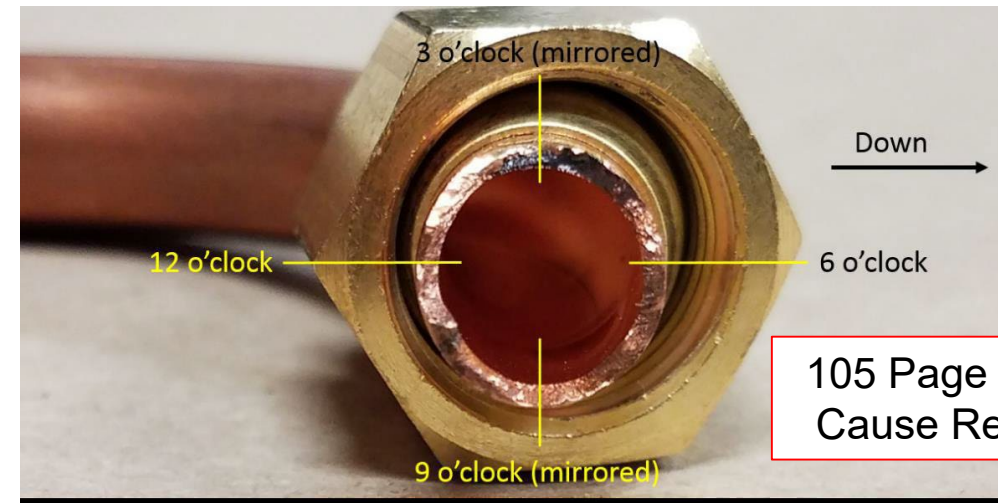
Instrument Air Line Failure Causes Plant Shutdown

- Instrument copper tubing failed at the compression fitting.
- The material and configuration of the instrument air tubing revealed the potential of a fatigue failure, workmanship error, physical impact, manufacturing defect, erosion or corrosion, etc.
- It was determined the failure mode of the copper tubing was vibration induced high cycle fatigue.
- Commonality in the current instrument air tubing fatigue failure and previous failures due to subtle workmanship errors is the use of copper tubing with brass fittings in the high vibration application during low power plant startup operations. Specifically, copper tubing with brass fittings is not robust enough to tolerate high vibration applications
- Many Stations have addressed this by replacing with flexible hose

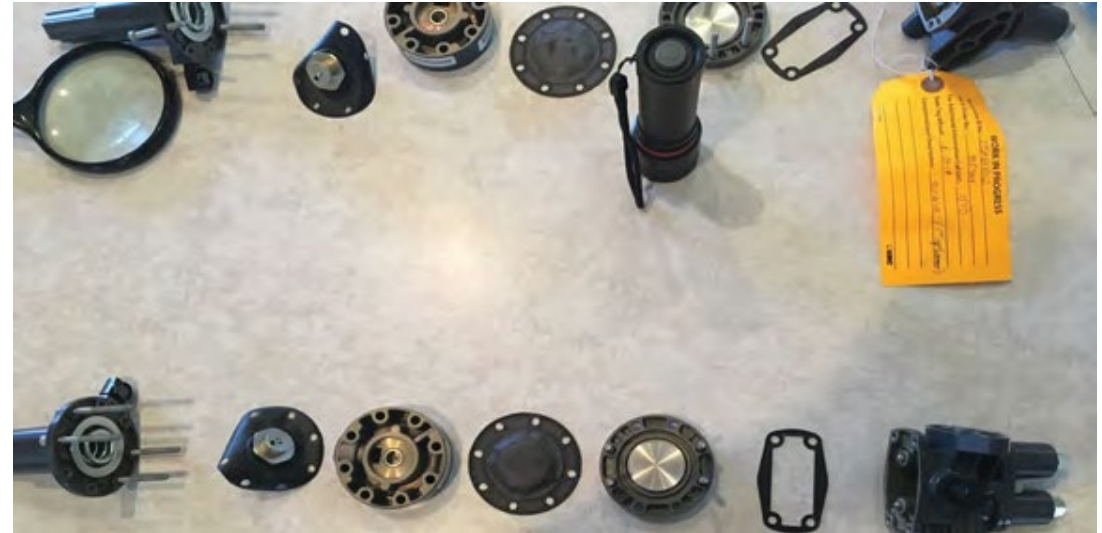
Wrong Response to a Leak Causes Shutdown

- The root cause of the automatic reactor trip was determined to be, contrary to station requirements an auxiliary operator took action to block air venting from the [very important] valve causing the valve to move in the closed direction.

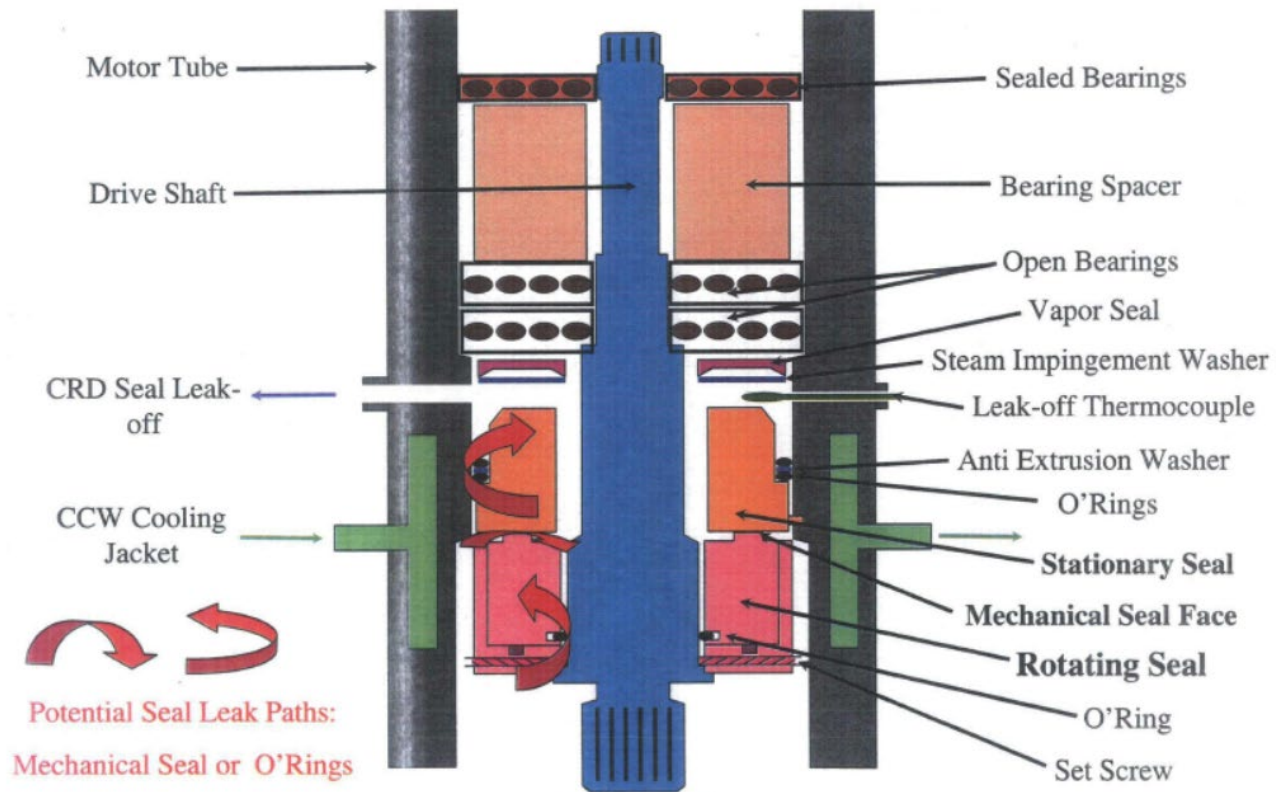
Control Rod Drive Seal Sketch

Control Rod Drive Seals are Causing Multiple Shutdowns

- There may not be just one common cause but several different causes such as:
 - Manufacturing issues
 - Assembly issues
 - Overall design issues
- Appears to be difficult mechanical seal application
- **Application is currently in only one US plant**

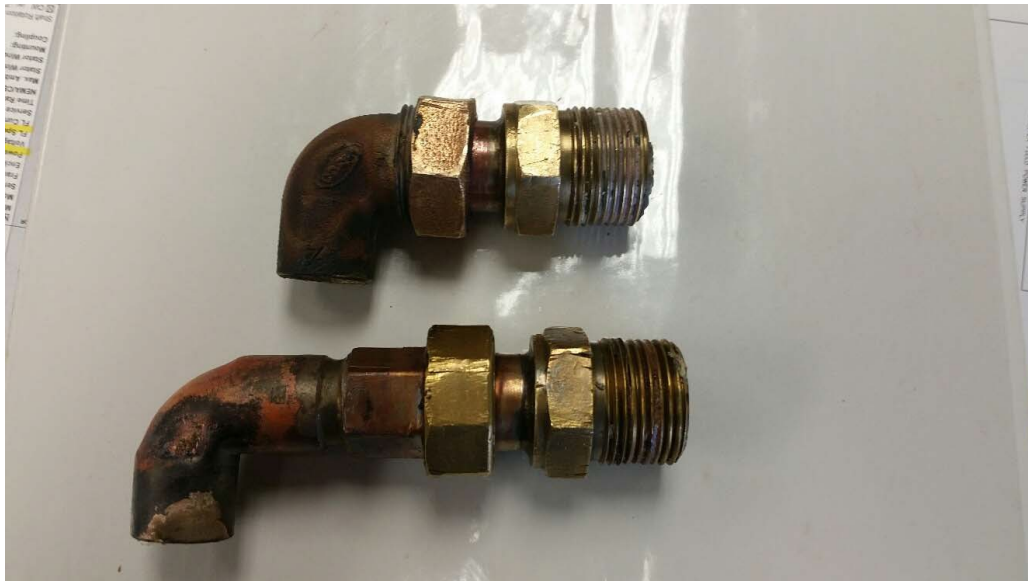
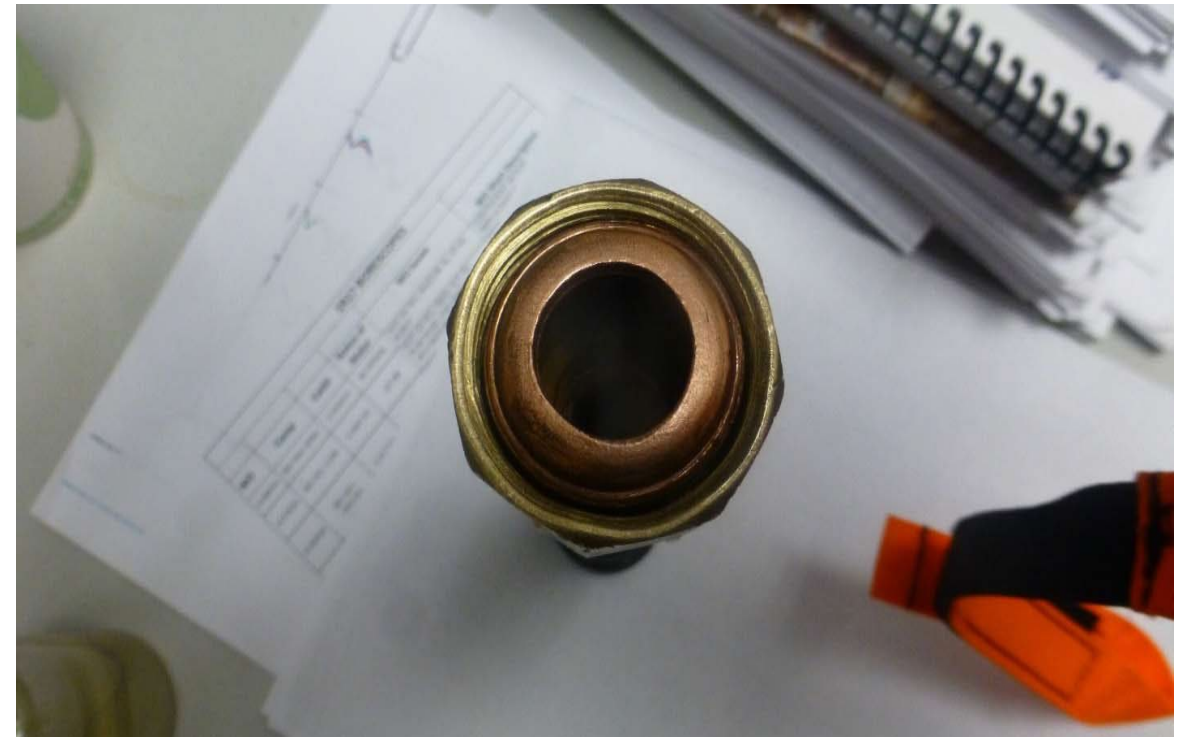
Power Reduction to 53% Due to Worn Out Fittings on a Condensate Pump

- The maintenance installation procedure for the motor does not require inspection or replacement of fittings during a motor replacement. **(CONTRIBUTING CAUSE)**

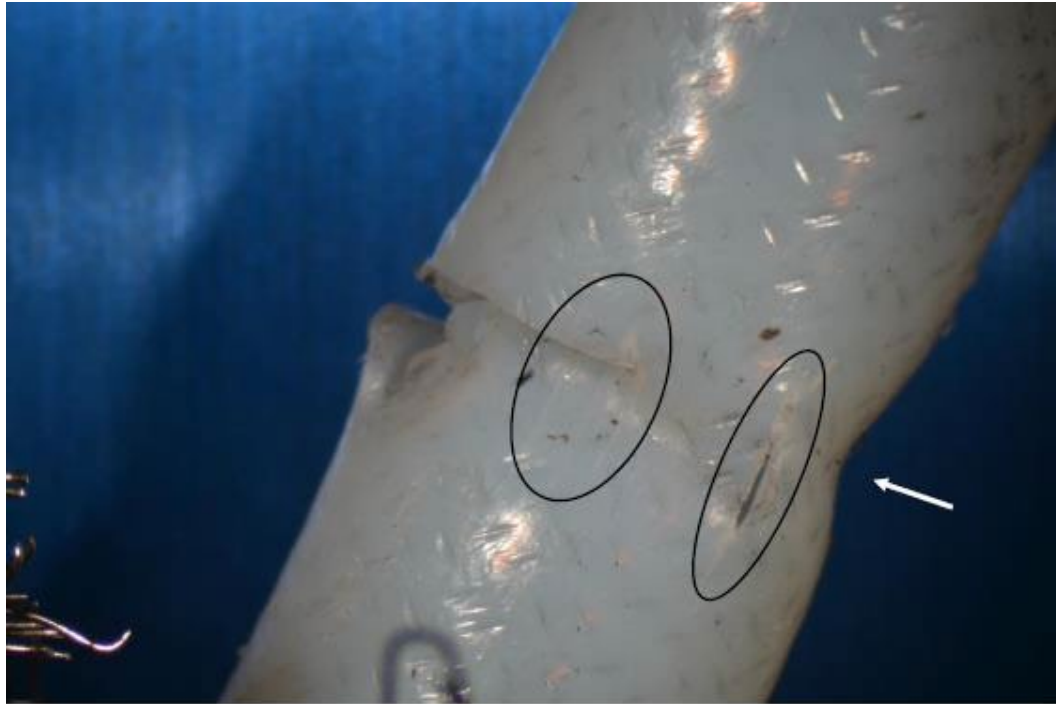
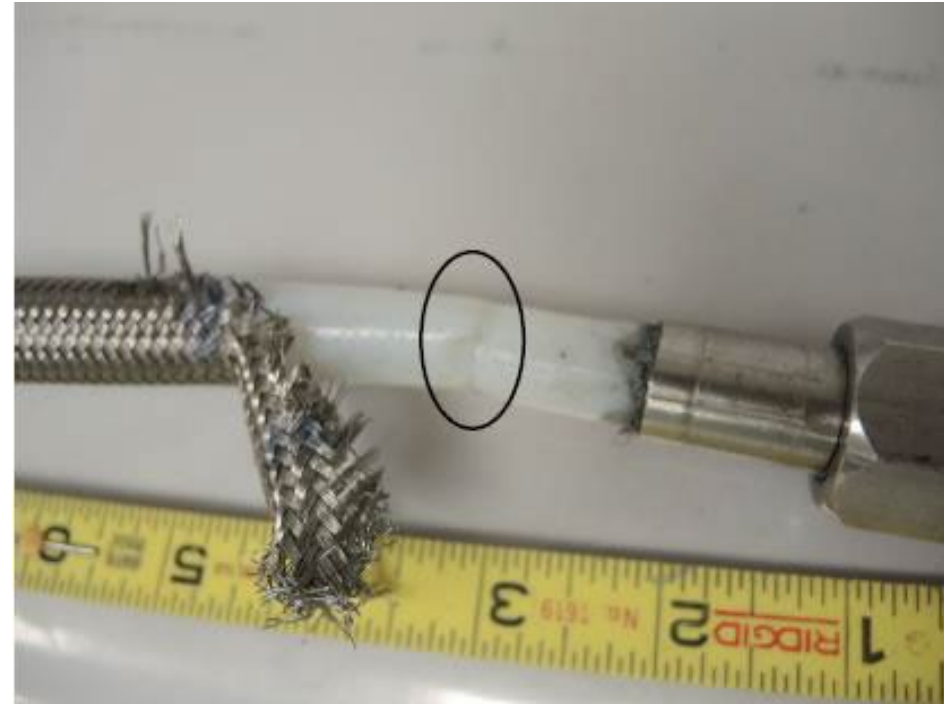
Low Recirc Pump Oil Level Resulted in a Downpower to 30% and Drywell Entry Caused by a Leaking Braided Hose

Installation/handling of the lower reservoir flexible hose that placed the hose in a kinked state which later propagated a circumferential tear

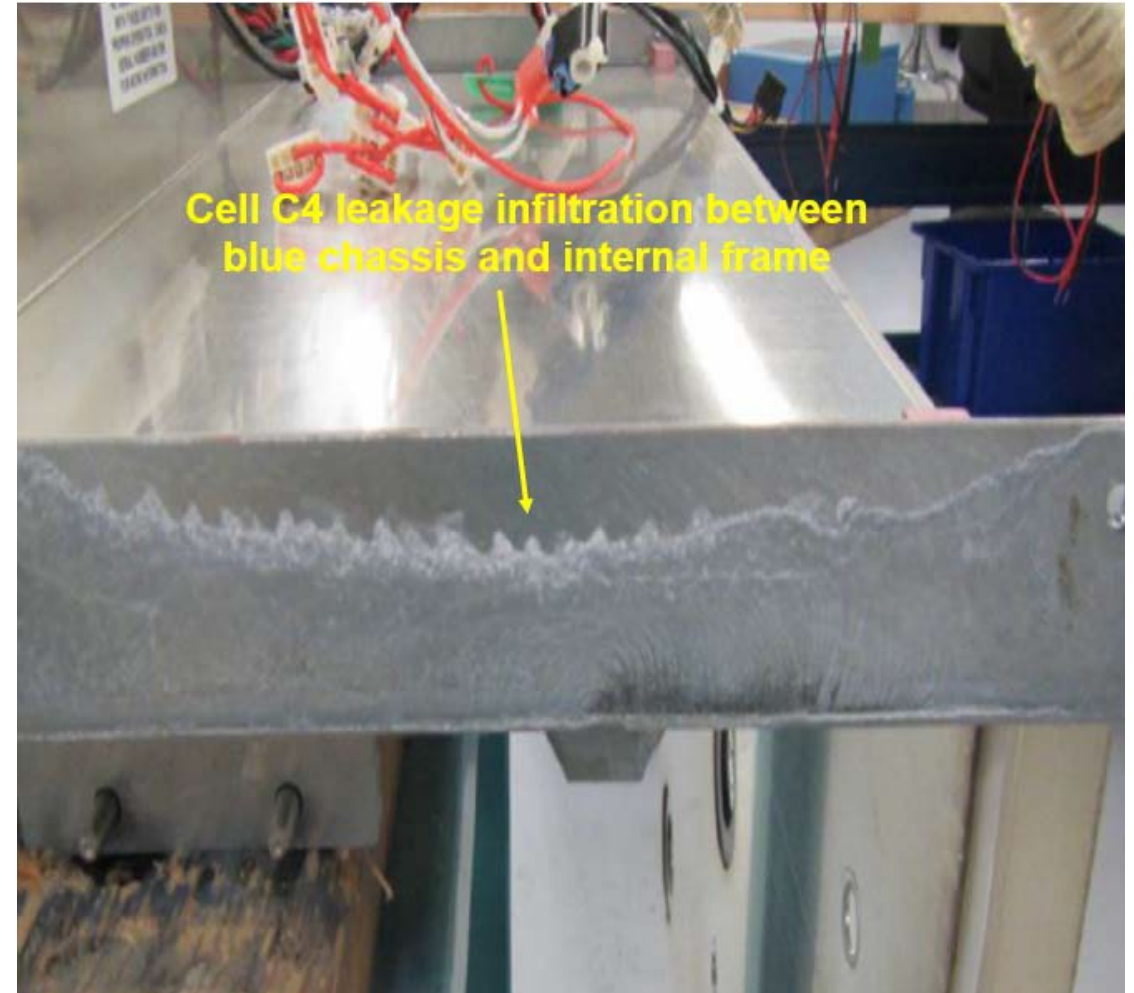
Leak on Adjustable Speed Drive Cooling Lines Causes Recirc Pump Trip and Power Reduction to 30%

- Manufacturing defect on bronze fitting caused leak resulting in electrical issues

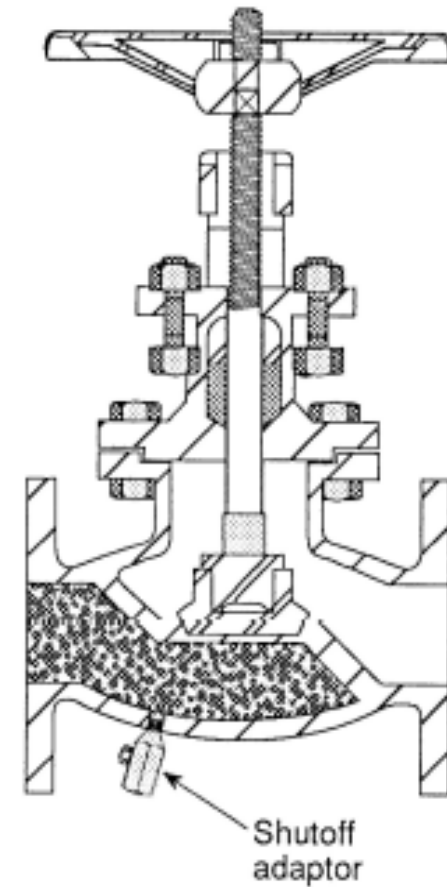
Rx Down Power to 13% Due to Elevated Drywell Identified Leakage Due to Double Isolation Drain Valves Leaking Through

- 41 year old valves leaked through
- Cut and cap action is being processed for approximately 30 lines with additional lines under review

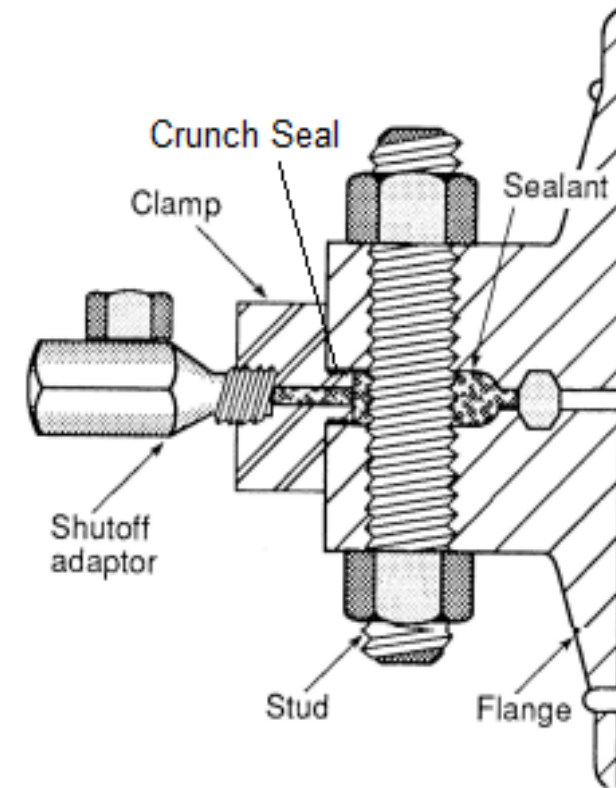
Typical Bonnet Leak Temporary Repair

Unplanned downpower to 79% Reactor Power for Temporary Repair Due to Leak on Valve Bonnet

- The valve was known to have a bonnet leak following the previous refueling outage. The valve was scheduled to be replaced during the outage modification.
- However, due to supplier delays in receiving the valve, the modification was removed from the outage without addressing a temporary repair from the previous cycle in place. Therefore, this was a business decision not to extend the outage to wait on the valve.

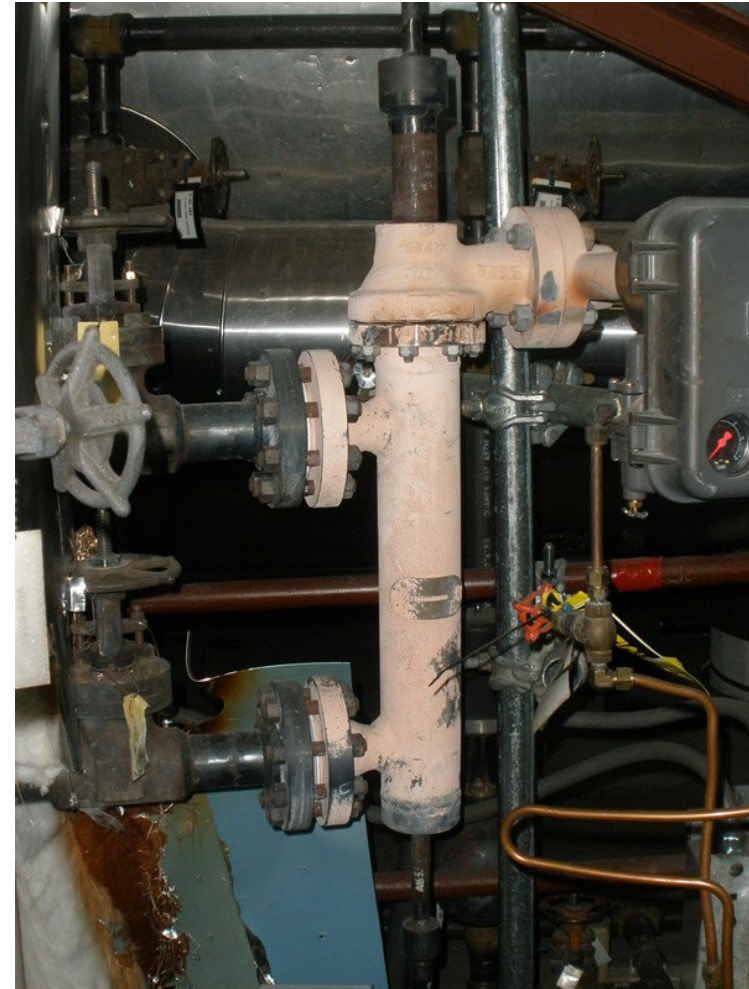
Level Transmitter Steam Leak Flanged Joint Resulted in a Downpower to 71% Power for approximately 12 hrs

- Less than adequate torque applied during work in 2009.
- Isolation of transmitter and created a single point vulnerability

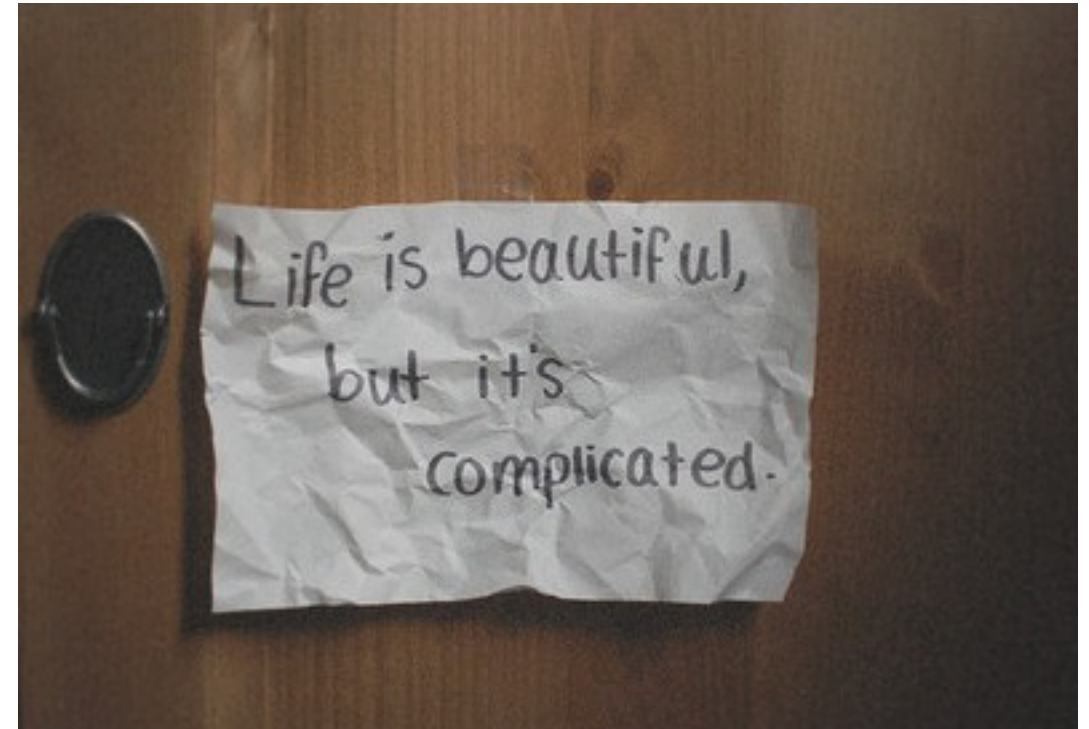
Manway Cover Installed Incorrectly Leads to Multiple Issues and Power Reduction to 78% Power

- Incorrect torque of manway cover bolts
- Torque used was for a 1.25" bolt BUT the bolt was 1.5" resulting in only a fraction of the required torque
- When the feedwater heater was removed from service for repair, it was removed incorrectly (wrong system line up) resulting in lifting of a relief valve and subsequent exposure to flow accelerated corrosion (FAC) conditions and through wall leaks resulting in degraded vacuum

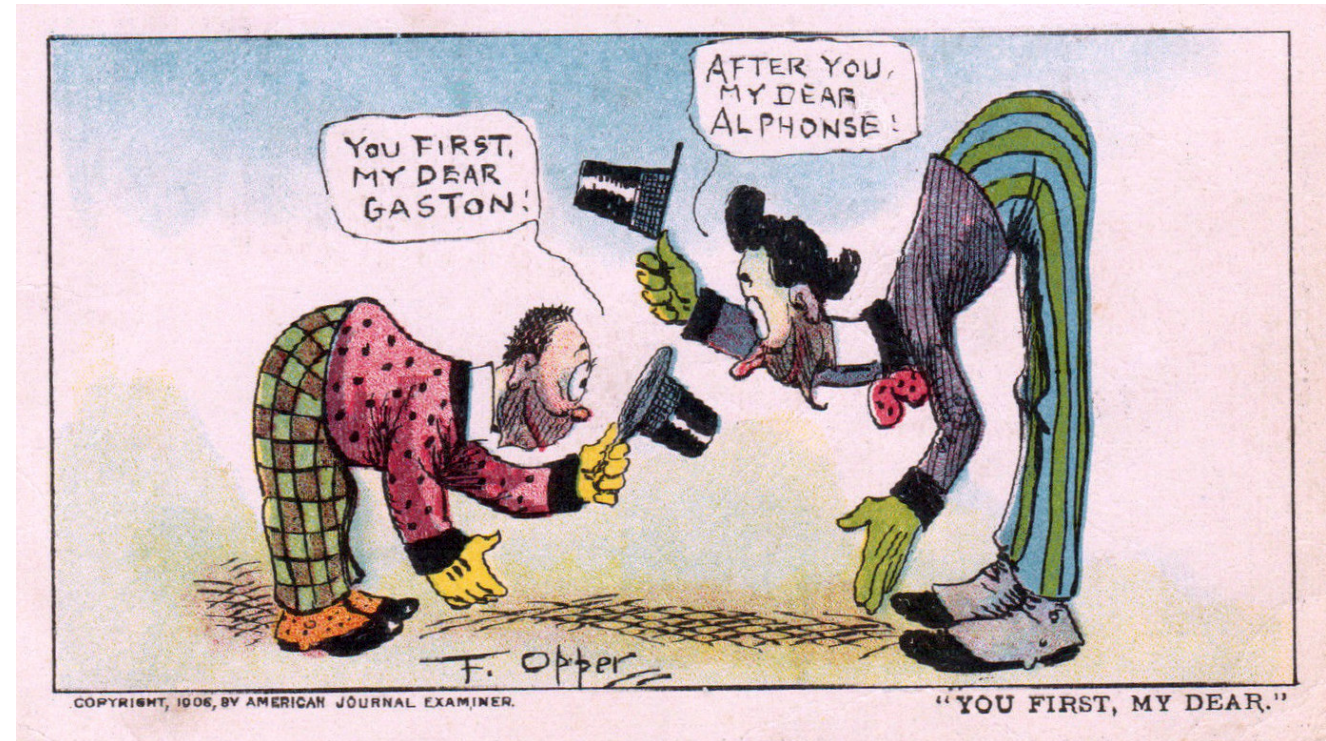
MSIV Packing Leak at BWR Results in Reduction to 75% to Tighten Packing

- Packing installers did not perform final torque/consolidation because they think the test team will do it
- The test team did not perform final torque/consolidation because the procedure is incomplete and they do not realize they need to consolidate packing
- Final packing configuration is not controlled

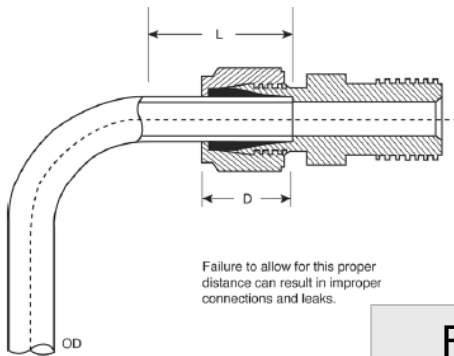
Figure 5-9
Tubing allowance for bends

There must be a sufficient straight length of tubing to allow the tube to be bottomed in the fitting (see Table 5-2 and Figure 5-9). A minimum length of straight tube from a compression fitting is recommended to ensure that a proper connection is made. In all cases, the fitting nut must travel back on a straight length far enough to enable inspection of both ferrules.

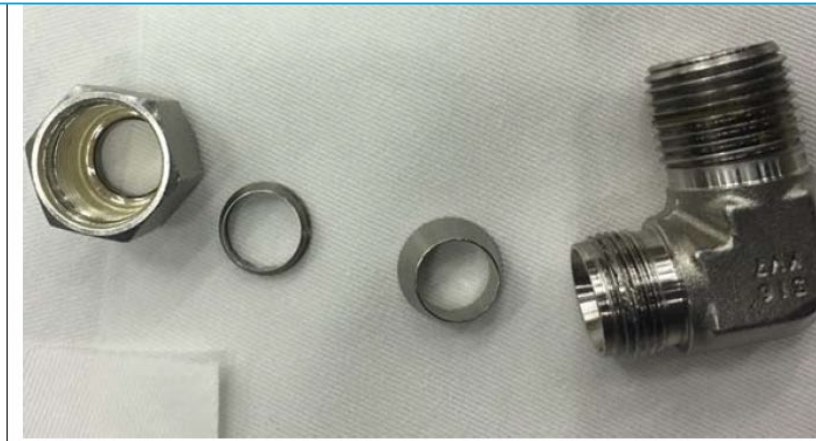
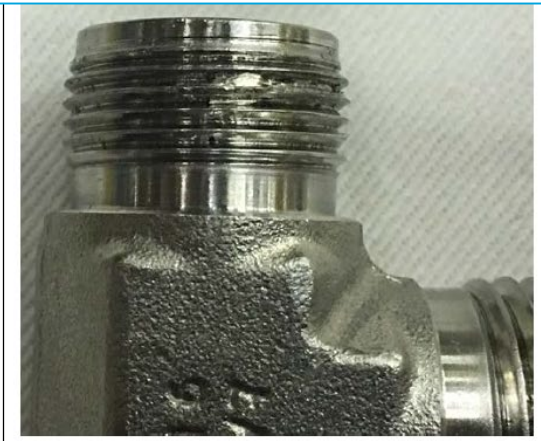
Unplanned Downpower to 5% Power Due to Oil Loss in the Reactor Recirculation Pump Motor Lower Bearing Oil Reservoir

Damage to threaded elbow caused by a side-load being exerted on the fitting nut caused by the tubing not entering the fitting straight which is a critical requirement for the Swagelok fitting assembly

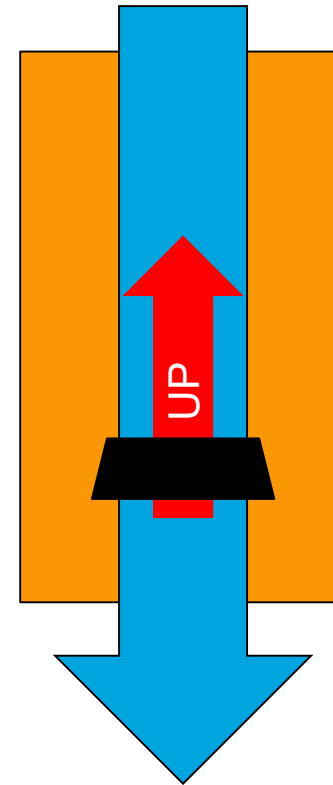
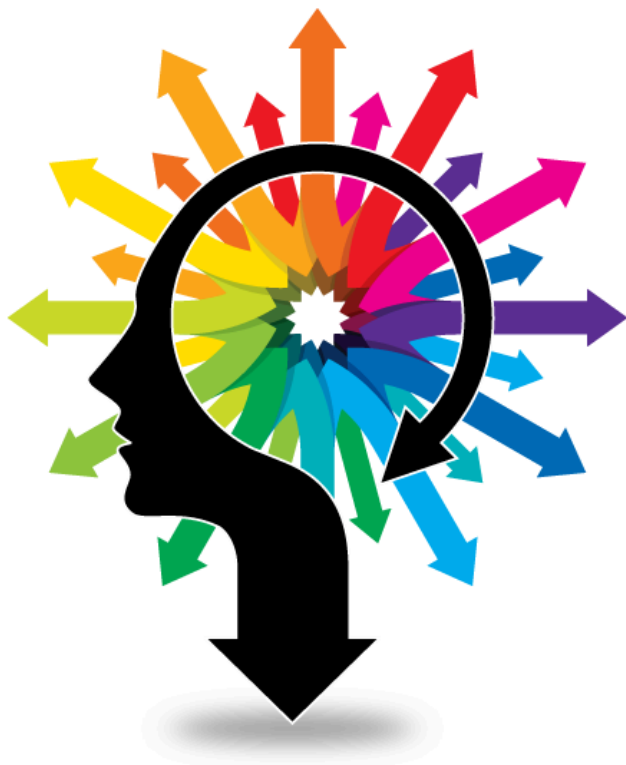
Oil Leak Due to Incorrectly Assembled Valve Actuator Causes Downpower to 50%

- Rod seal assembly was installed backwards during previous maintenance
