2017 and 2018 (so far) OE Review

Gary Boles
Principal Technical Leader, NMAC
FLMUG
January 2019

Leaks Causing Shutdowns 2018 (reported as of 10/18)

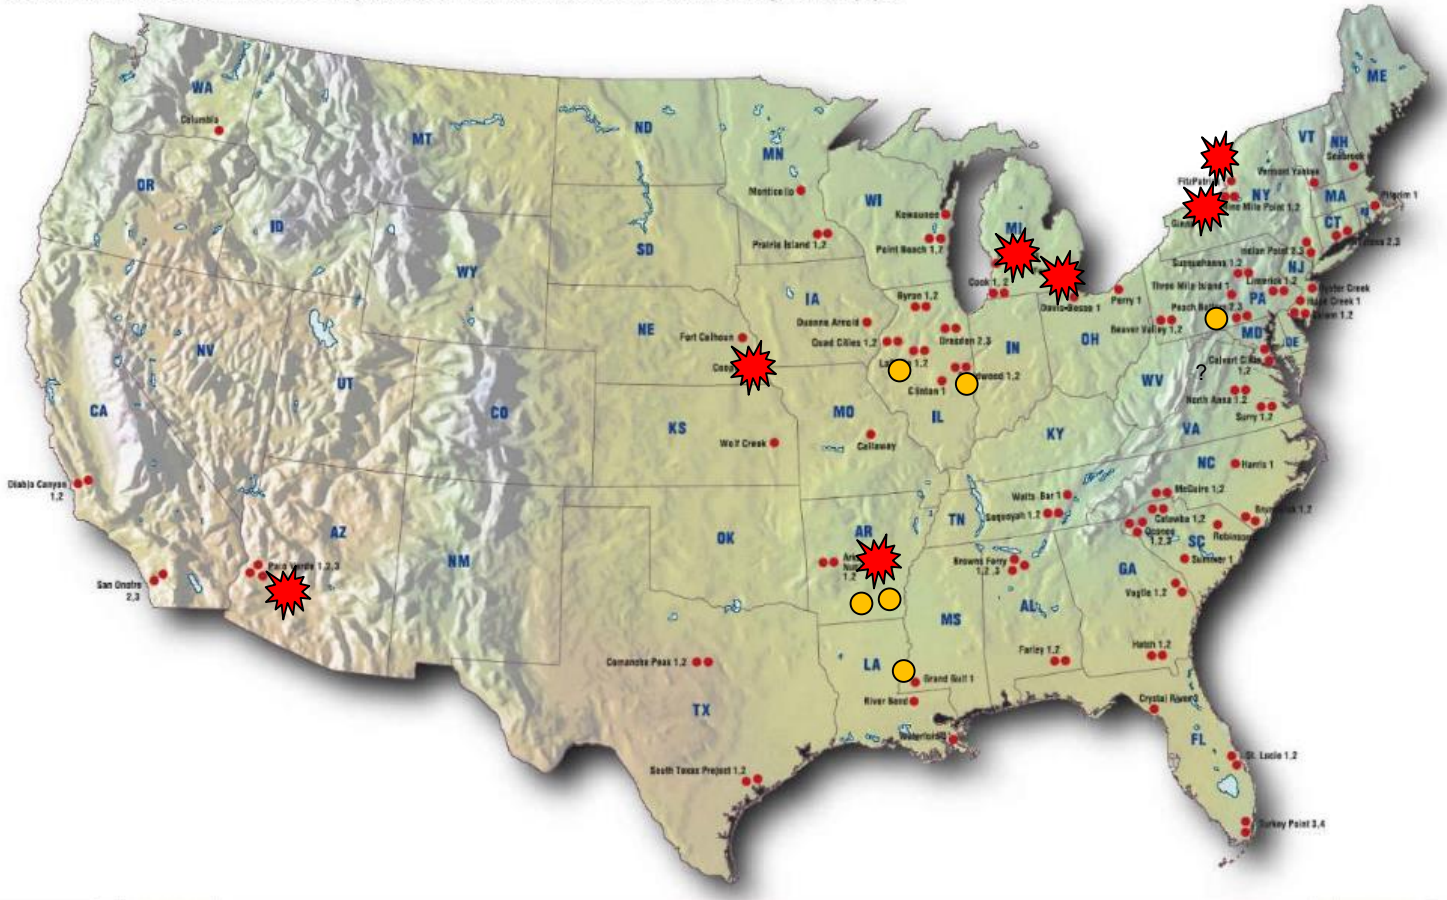
- Weld or base metal leaks
- ★ Replaceable Seal Leaks

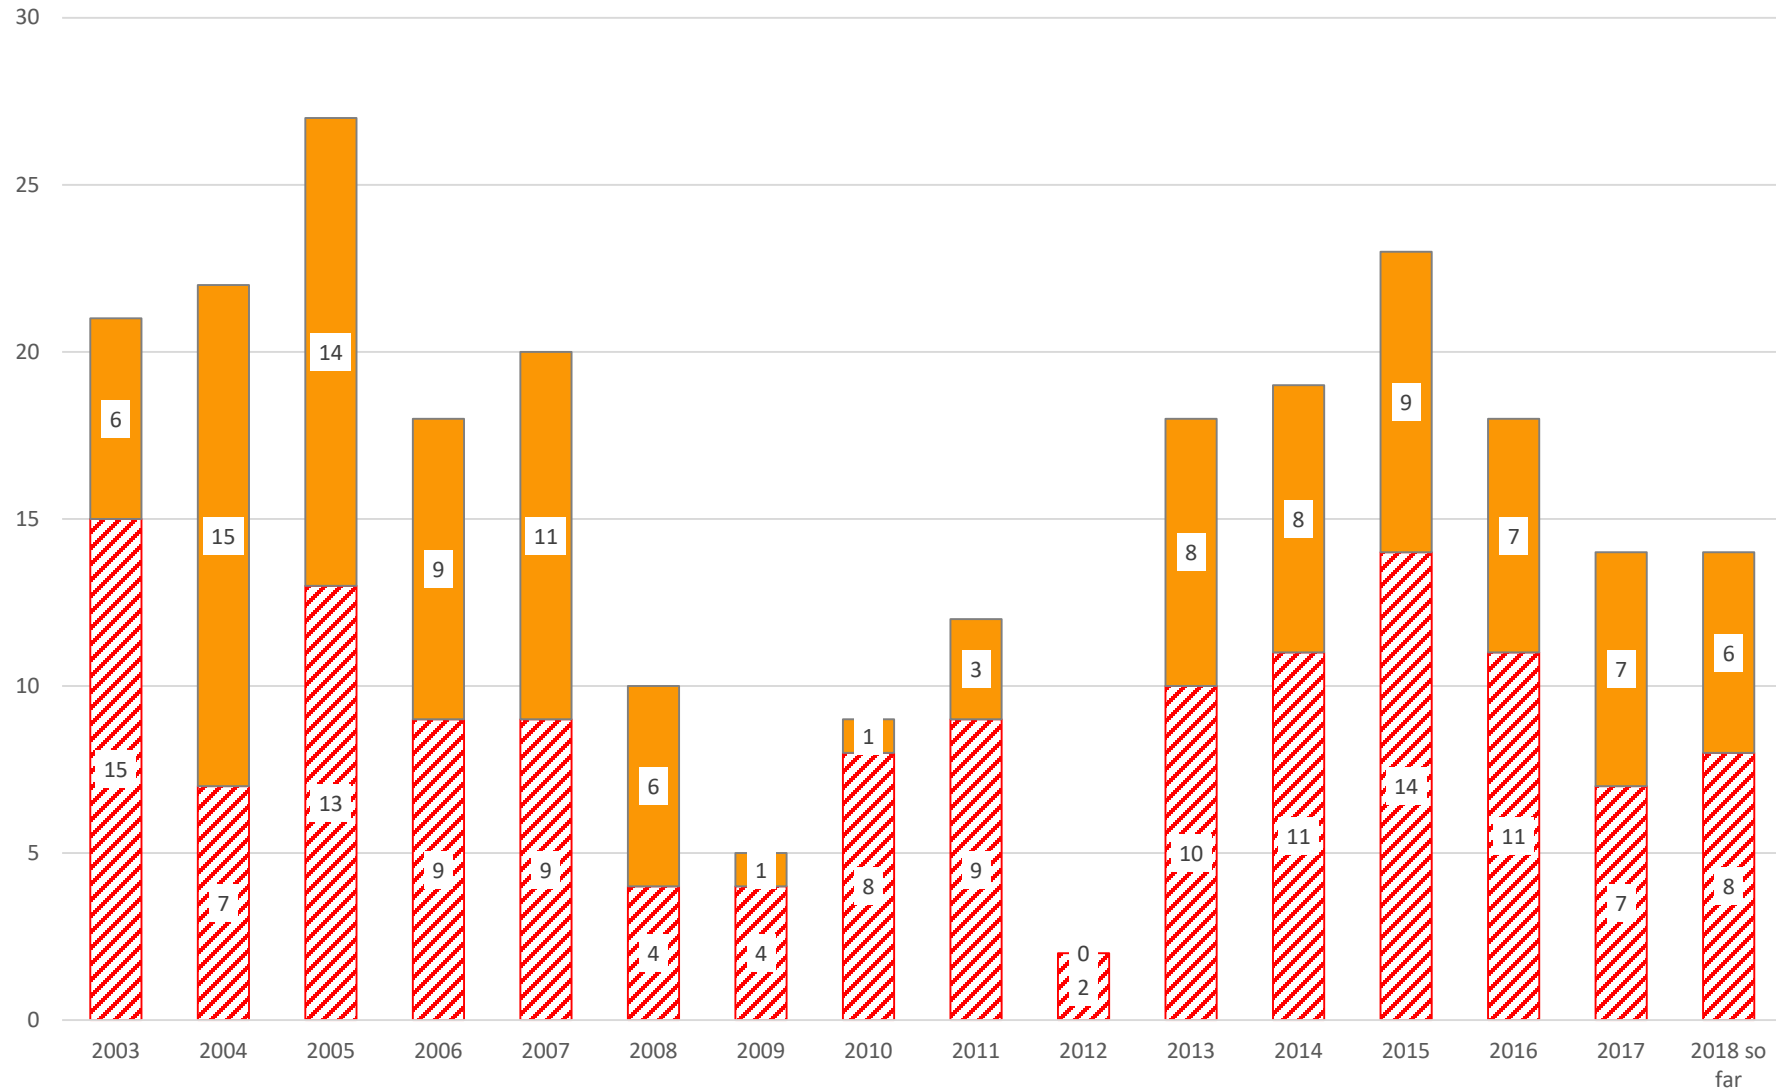
External Leaks Causing Shutdowns in US Nuclear Plants in ICES Database as of 12/3/18

Replaceable Seals and Joints
 Welds, Base Metal, etc.
